# Landslide caused problems underground

**ABSTRACT:** On October 5<sup>th</sup>, 2010, cracks were found in a gallery 1.80 m high and 1.40 m wide. The gallery is 100 years old and runs parallel to a valley flank. After eliminating several possible causes of cracking, a landslide producing the damages had to be taken into consideration. Monitoring revealed that a landslide was occurring, loading the gallery lining. As stabilization of the slope was not an option for several reasons, it was decided to replace the gallery by a new one deeper inside the slope, which will be ready for operation in 2017. Thus the old gallery has to be kept in operation till then and it was decided to reinforce the old gallery by a heavy reinforced shotcrete lining 10 cm thick. However, it has to be realized that stiffening the support of a tunnel in a landslide attracts the stresses and the tunnel is greatly damaged in the long term. Nevertheless, it may be a positive measure in order to allow a structure to survive a particular span of time.

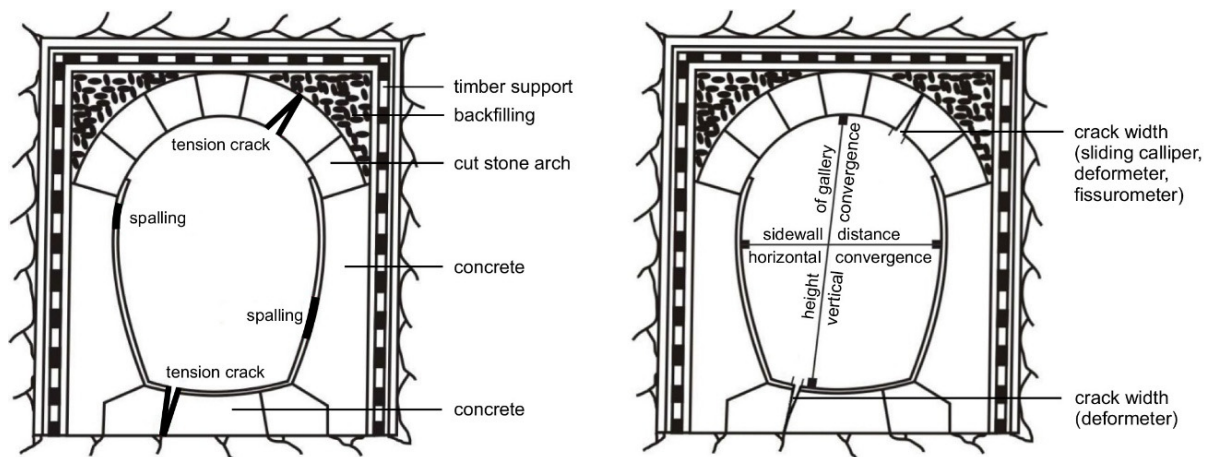
Figure 1. Gallery cross section with damage pattern and monitoring programme (measured distances).

On October 5<sup>th</sup>, 2010, cracks and spalls were found in a 30 m long section of a gallery 100 years old, which had not been observed before (Figure 1). The gallery had been excavated in a tectonically strongly stressed and therefore highly disintegrated, weathered and slightly dipping sandwich of clayey shales, sandstones and marls belonging to the Flysch-zone very close to the thrust by the Northern Calcareous Alps. Geological mapping and reconnaissance drilling revealed that the sandwich described above is covered by 5 m of weathering loam and a rock debris layer 4 m thick. Overburden of the gallery amounts to some 25 m. The excavation had been supported by a timber structure and a U-shaped profile had been cast. The crown had been supported by a cut stone arch (Figure 1).

After eliminating several causes, to which the particular damage pattern (Figure 1) could have been attributed, a landslide deforming the gallery had to be regarded as the most probable cause for

Monitoring of crack widths started in October 2010 and showed that crack widths were increasing 1.5 mm per year. In March 2012, fissurometers measuring relative displacements of crack surfaces in 3 dimensions were installed at the crack in the roof parallel to the gallery axis (Figure 1). Convergence measurements started in October 2010 and showed that sidewall distances (horizontal convergence) were increasing 3.5 mm per year whereas the height of the gallery (vertical convergence) was decreasing 2.5 mm per year (Figure 4).

As slope displacements as well as deformations of the gallery have been going on, the owner of the gallery decided to replace the old gallery by a new one deeper inside the slope (outside of the landslide) and ready for operation in 2017. Therefore, the old gallery has to be kept in operation till then and it was decided to strengthen the old gallery by a 10 cm thick, heavily reinforced shotcrete lining, which was put in place in October 2012.

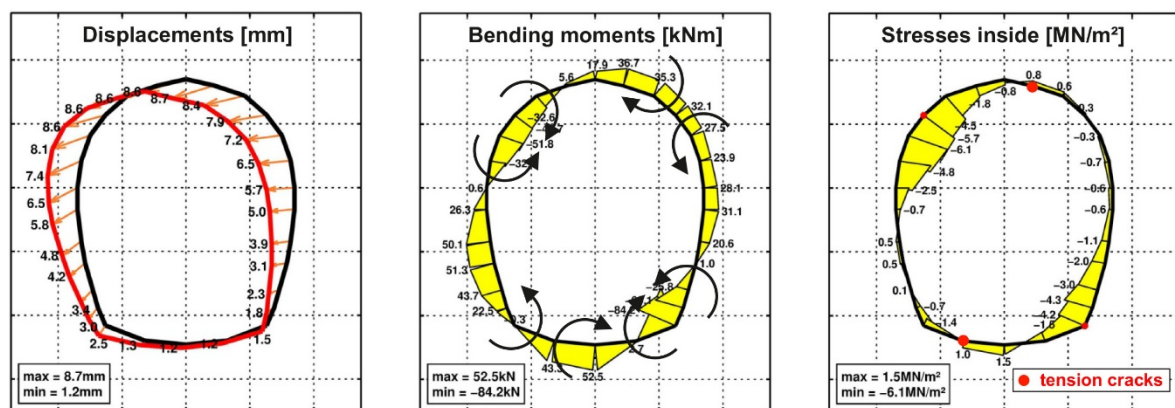
Figure 2. Calculated displacements, bending moments and stresses in the gallery support resulting from a simulation of the system landslide – gallery in a profile along the dip direction of the slope using FLAC (Itasca 2011)

the damages (Poisel et al. 1996). Modelling of the system landslide – gallery in a profile along the dip direction of the slope using FLAC (Itasca 2011; Fig. 2) showed an identical damage pattern in the gallery support as observed (Fig. 1).

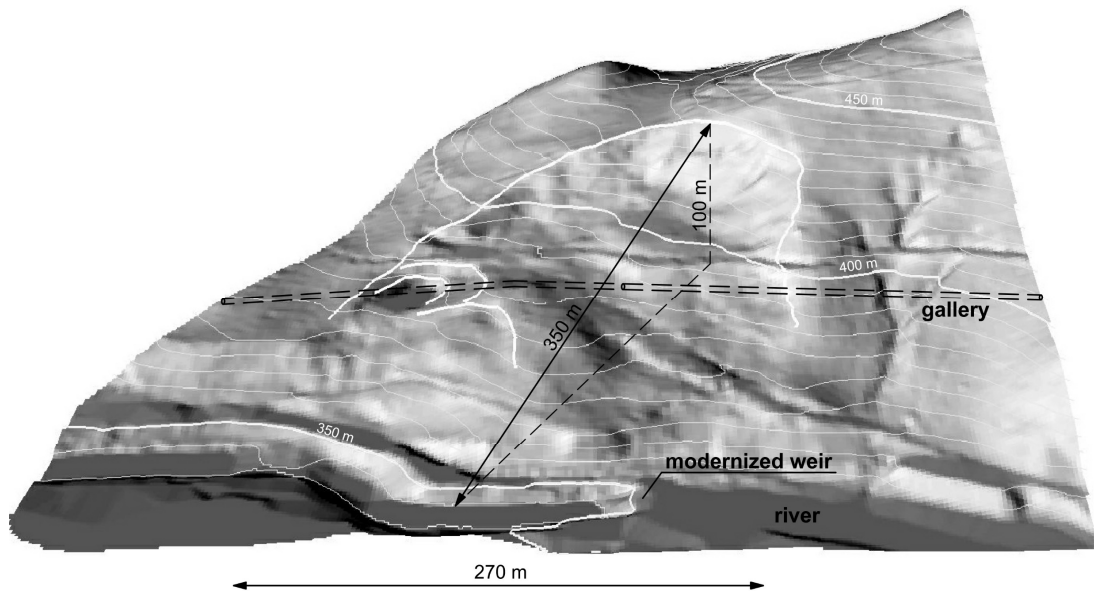
Figure 3. Morphology of the slope (laserscan data recorded in 2011).

The gallery is running parallel to a slope some 110 m high (Figure 3). At the toe of the slope a weir is situated which was modernized in 2009 and 2010. In doing so the reservoir level, which is kept constant during operation, has been increased by 1 m, the tailwater level has been decreased by 1.10 m over a length of ca. 300 m and at the toe of the slope some 20,000 m<sup>3</sup> had to be excavated in order to make space for a fish migration device. Additionally in the summer of 2009 210 mm of rain fell in 4 days measured at a nearby weather station, which had occurred three times since the construction of the gallery. Therefore it had to be assumed that most probably both events (modernization of the weir as well as the precipitation event of 2009) reactivated an old, dormant landslide.

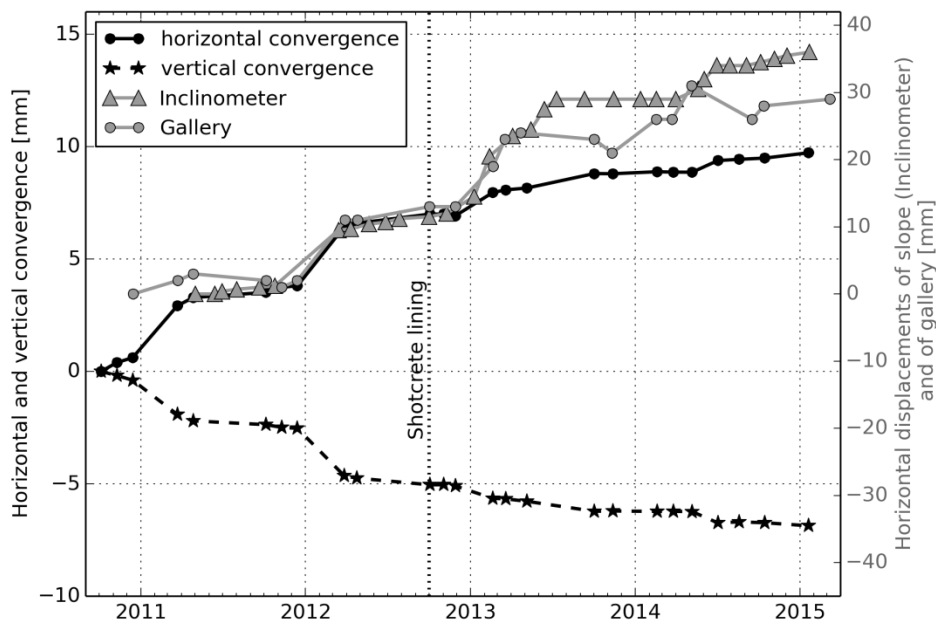
Figure 4. Horizontal and vertical convergences of gallery in the damaged section, horizontal gallery displacements of damaged section and horizontal slope displacements (inclinometer) over time.

A comparison of slope displacements (Figure 6) and gallery deformations (Figure 4) over time reveals that phases of larger slope displacements and phases of larger gallery deformations coincided until October 2012 when shotcrete support was constructed (afterwards gallery deformations occurred only to a very limited extent.). Thus, most probably the landslide causes the gallery damage.

Strengthening the old gallery by a shotcrete lining led to a significant decrease of gallery deformations (Figure 4) as simulated by numerical modeling. Therefore, the shotcrete in the central part of the damaged section of the gallery shows no cracks until now. However, strengthening could not reduce displacements of the gallery as a whole due to landslide displacements immediately after construction of the shotcrete lining until spring 2013 (Figure 4). As a consequence, diagonal tension cracks opened in the roof of the gallery in the transition zones unmovable ground – landslide. Two causes can be assigned for the formation of these cracks. Firstly, the strengthened gallery acts like a beam loaded by the landslide movement. Thus, diagonal tension cracks are formed by shear stresses. Secondly, the gallery is rotating in the section affected by the landslide because landslide displacements are decreasing with depth. Therefore, the gallery is fixed in unmovable ground and rotated inside the landslide shear zone. This leads to torsional stresses and formation of tensile cracks in the transition zones unmovable ground – landslide and landslide – unmovable ground. The question is whether the oblique tension cracks in the transition zones (and not the central part, where the gallery is completely inside the shear zone) due to shearing and torsion will impair the operational reliability of the gallery, even though the gallery is needed only for a limited time span.

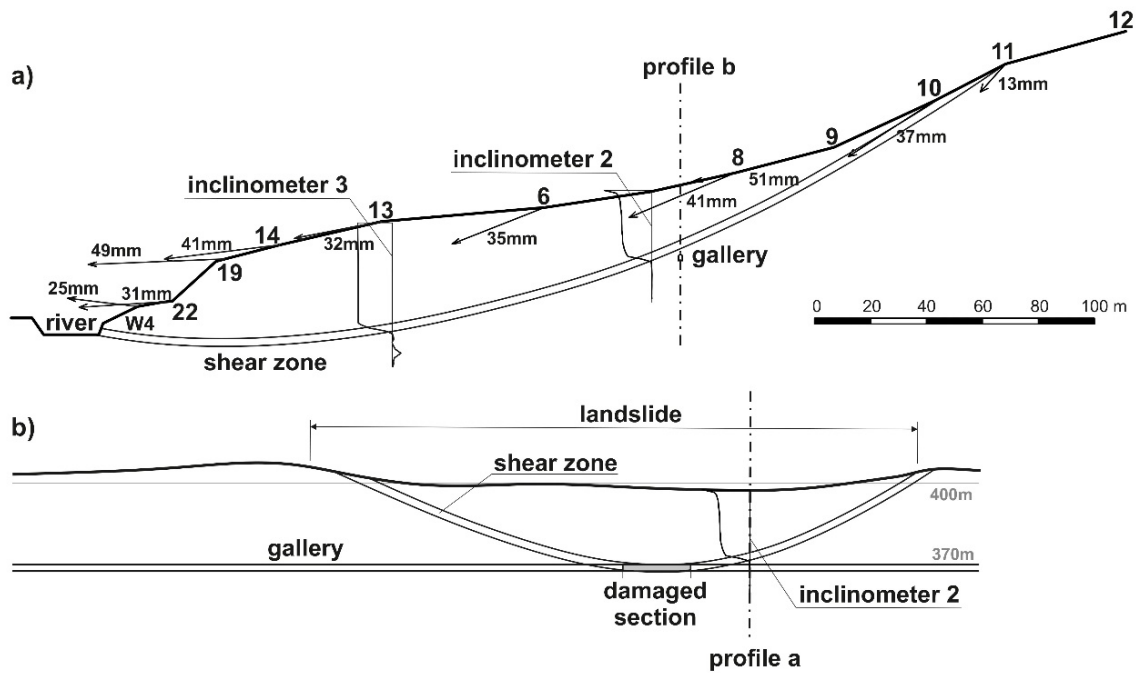
Monitoring of the slope started with a geodetic survey in November 2010; which provided displacement vectors with a length of some 50 mm between November 2010 and October 2014 shown in Figure 5.

Inclinometer 1 (later replaced by inclinometer 2) was installed in April 2011 near the gallery in the upper part of the slope (Figure 5). Inclinometer 3 was installed in December 2012 in the lower part of the slope. The results of the inclinometer measurements revealed that an almost rigid block moves downslope on an approximately 2 to 3 m thick, fully developed shear zone.

spatial model of the landslide can be developed (Figure 5), which leads to the geometry of a bowl shaped, rotational landslide with a volume of about 1 Mio m<sup>3</sup>.
